Mesa Active Adult Center

Facilities Assessment Preliminary Cost Estimate & CDBG Grant Request

DRAFT November 2014

Michael Wilson Kelly-Architects, Ltd.

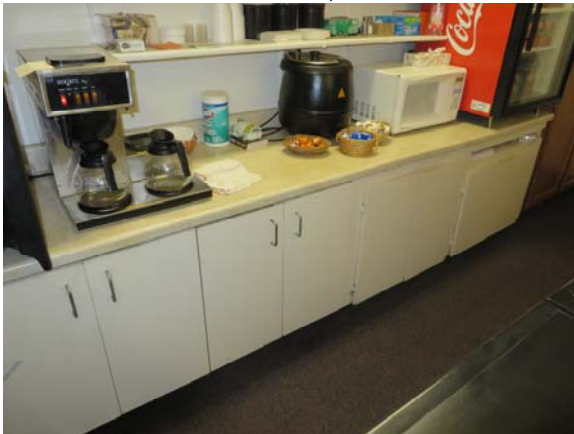
All the millwork cabinets and countertops are dilapidated and their widely varying color schemes are very dated. All countertops with sinks and backsplashes are exhibiting water caused de-lamination and fading color making them nearly impossible to match or repair. Many of the counters do not meet current ADA accessibility requirements for height, service, and knee clearances. Some of the cabinets that need to be locked are chained together via their hardware pulls.

CAFÉ (Area 2): The back counter needs to be replaced and storage improved. A hand wash sink is needed in order to meet Environmental Health Code. The free-standing front counter is to remain, and finishes for the back counter are to match.

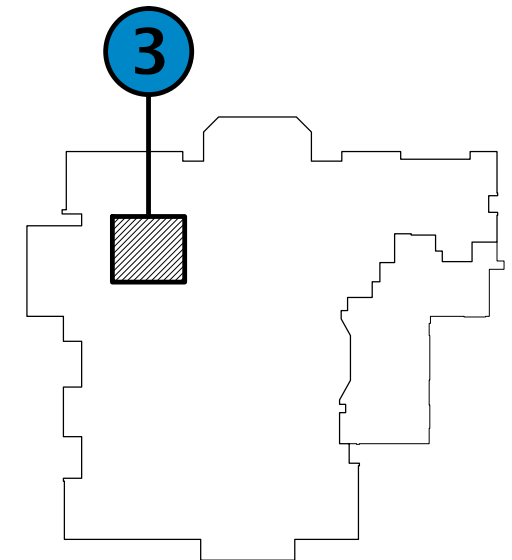
3 RESTROOM

The Toilet Partitions are worn, soiled, out of plumb, and in need of modification to meet modern ADA accessibility standards.

1. MODIFY (REMOVE 1 TOILET) FOR NEW A.D.A. STALL.
2. REMOVE AND REPLACE EXISTING SINKS AND FAUCETS AND PROVIDE NEW SOLID SURFACE COUNTERTOPS.
3. REMOVE EXISTING PARTITIONS. PROVIDE NEW HDME SOLID (PLASTIC) PARTITIONS
